**TECHNICAL MEMORANDUM  
IN-WATER REMOVAL WORK**

**Bradford Island Landfill  
Cascade Locks, Oregon**

**October 2002**

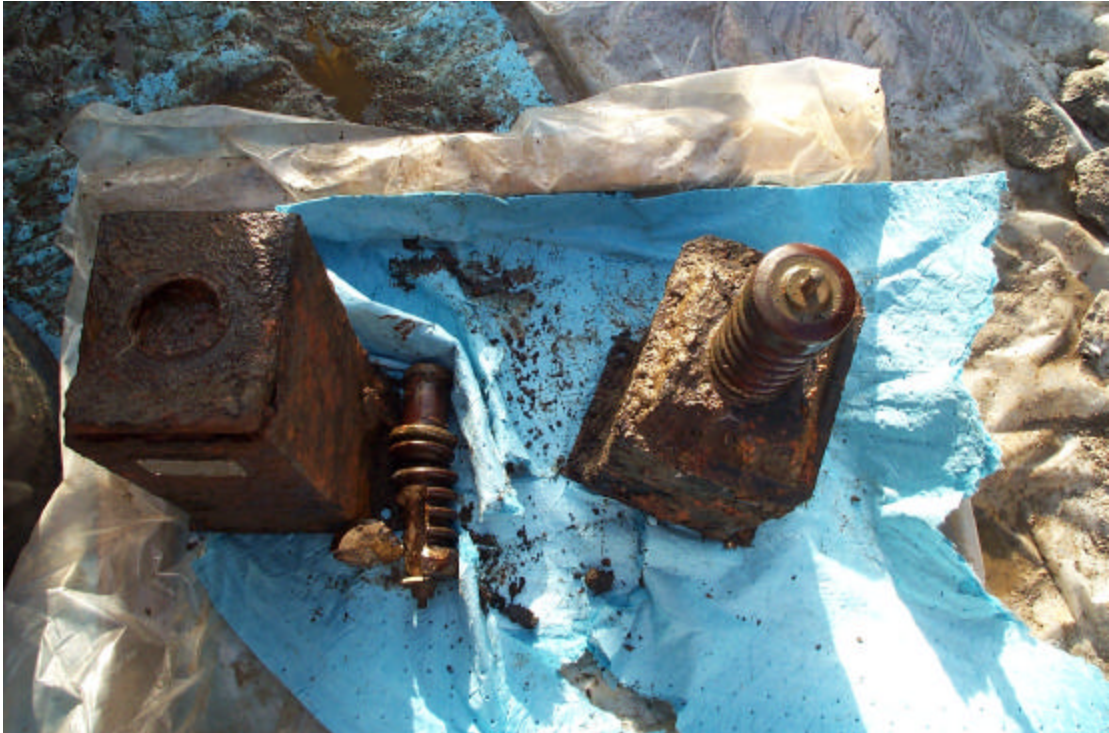
<b>Client Name:</b> United States Army Corps of Engineers		<b>Site Location:</b> Bradford Island	<b>Project No.</b> 52-00080001.08
<b>Photo No.</b> 9

<b>Direction Photo Taken:</b> NA			
<b>Description:</b>  Inerteen capacitors.

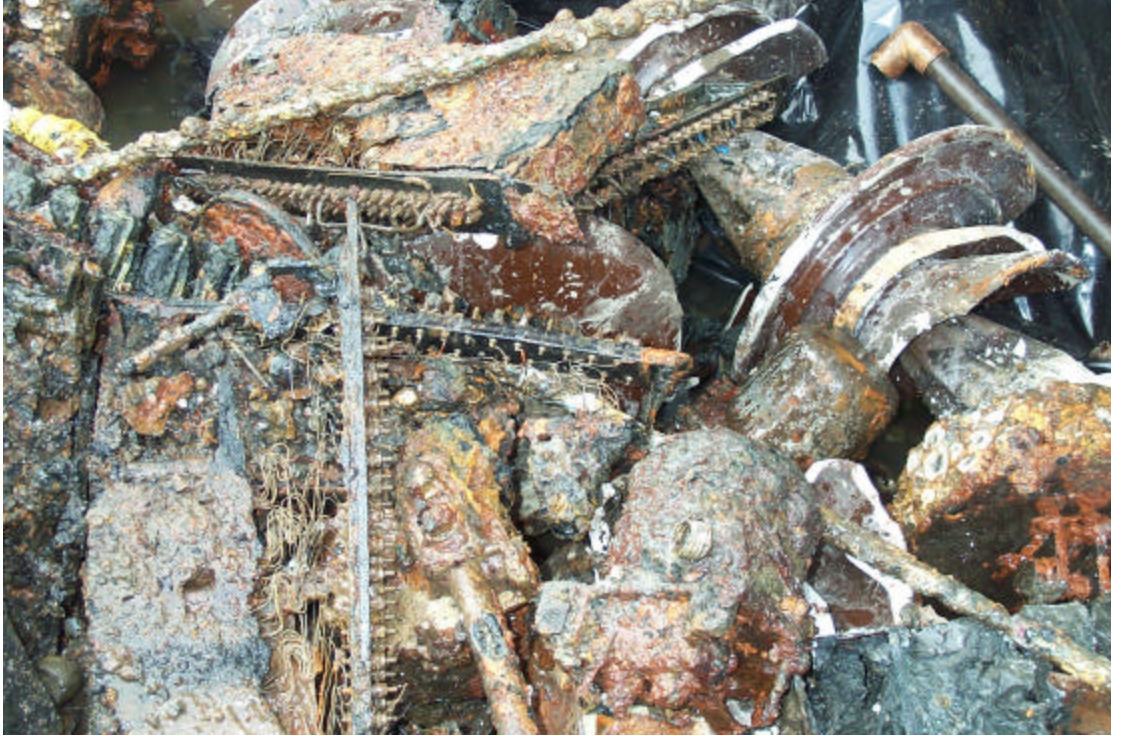
<b>Client Name:</b> United States Army Corps of Engineers		<b>Site Location:</b> Bradford Island	<b>Project No.</b> 52-00080001.08
<b>Photo No.</b> 21

<b>Direction Photo Taken:</b>  NA			
<b>Description:</b>  Communication boxes and post insulator.

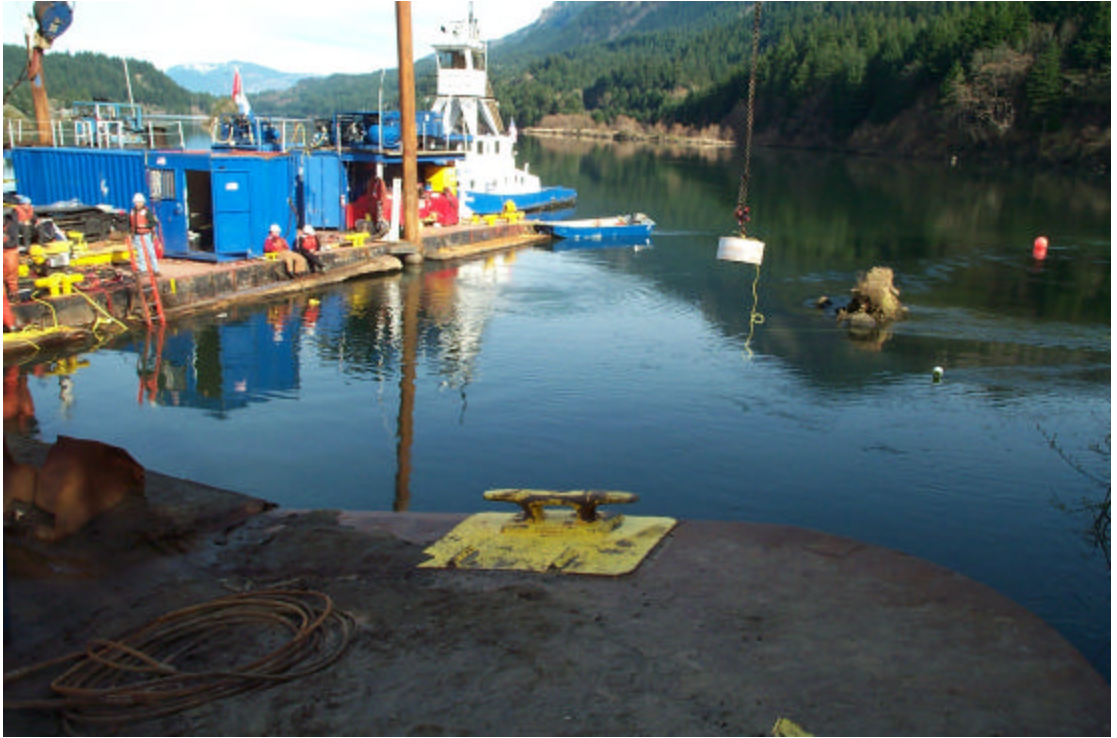
<b>Client Name:</b> United States Army Corps of Engineers		<b>Site Location:</b> Bradford Island	<b>Project No.</b> 52-00080001.08
<b>Photo No.</b> 29

<b>Direction Photo Taken:</b>  East			
<b>Description:</b>  Placing anchors at Pile #1.

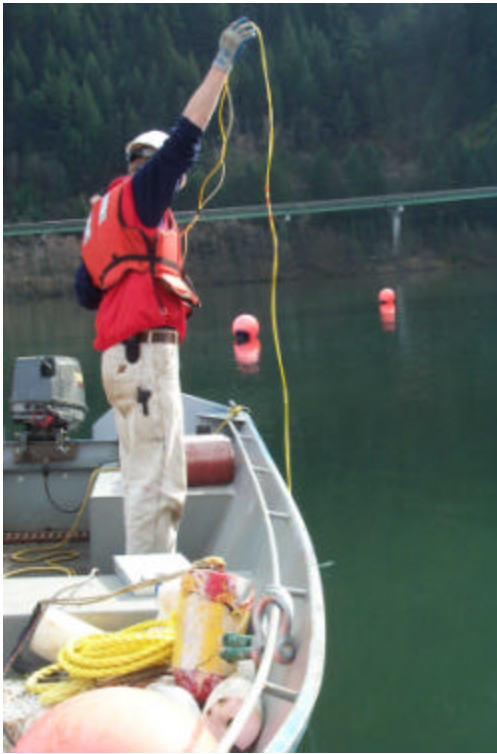
<b>Client Name:</b> United States Army Corps of Engineers		<b>Site Location:</b> Bradford Island	<b>Project No.</b> 52-00080001.08
<b>Photo No.</b> 33

<b>Direction Photo Taken:</b>  South			
<b>Description:</b>  Placing turbidity probe in water.

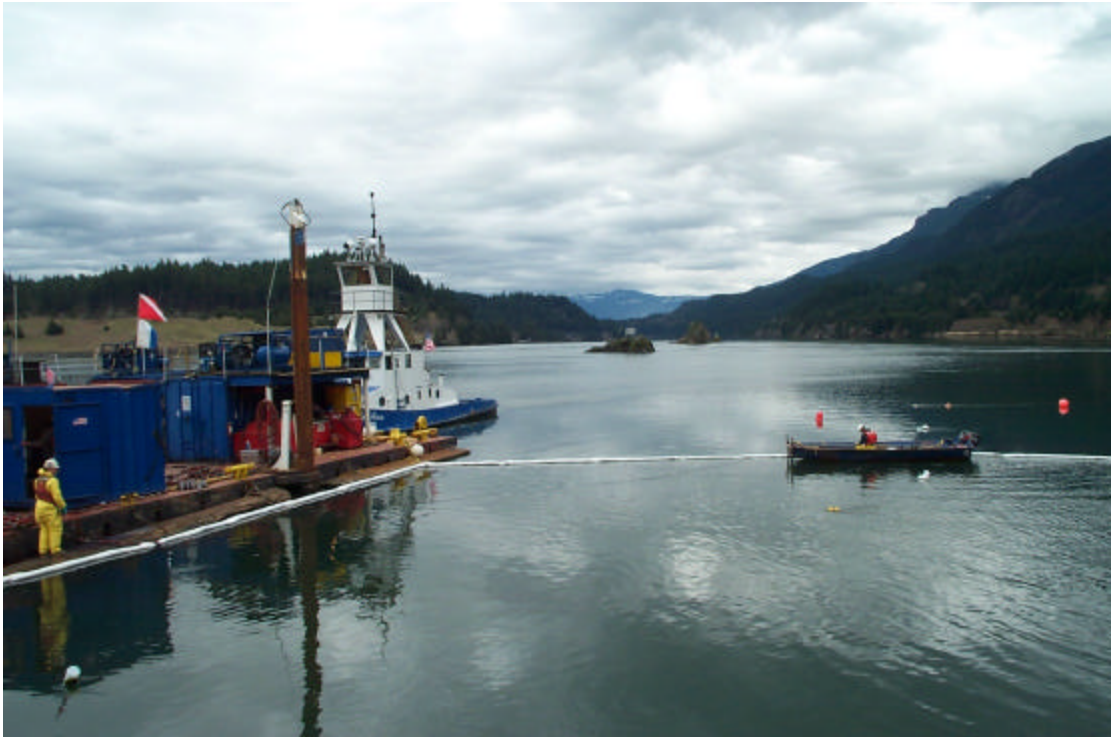
<b>Client Name:</b> United States Army Corps of Engineers		<b>Site Location:</b> Bradford Island	<b>Project No.</b> 52-00080001.08
<b>Photo No.</b> 35

<b>Direction Photo Taken:</b>  East			
<b>Description:</b>  Turbidity monitoring at Pile #1.
